**== USS TAYLOR (FFG-50) ==**  
**SEMAT II SHELL CONDITION ASSESSMENT**  
**SURVEY**  
**INTERIOR AREAS**  
**10/29/01 TO 11/09/01**

**PREPARED BY**  
**SUPERVISOR OF SHIPBUILDING CONVERSION**  
**AND**  
**REPAIR**  
**PORTSMOUTH, VIRGINIA**  
**11/10/01**

9 November 2001  
Serial# 1697AY – 118

Q.E.D. Systems, Inc. was tasked by the Supervisor of Shipbuilding Conversion and Repair, USN (SPORT) Portsmouth, VA to conduct an Ultrasonic Thickness (U/T) Survey of specific locations on board USS TAYLOR (FFG-50) during the period of 31 October 2001 – 8 November 2001.

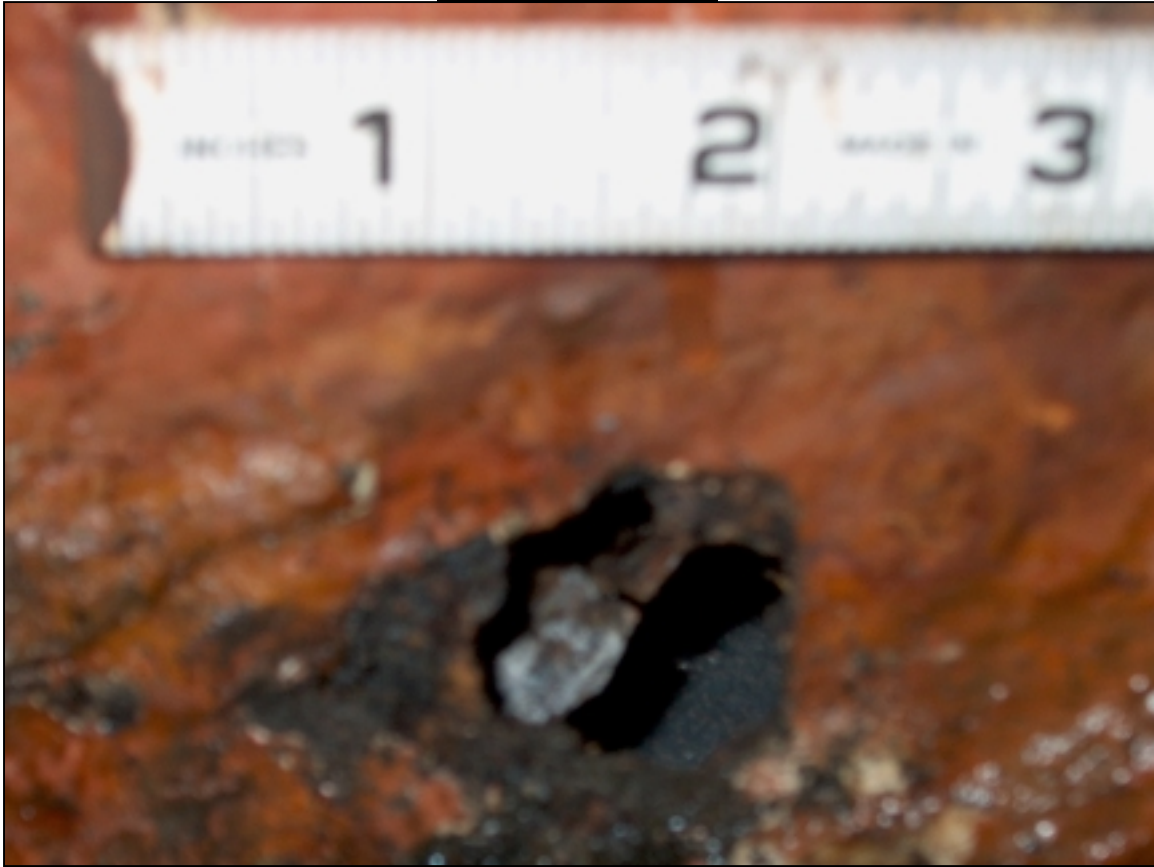
| LOCATION | AREA | RESULTS |
|---|--|---|
| 4-140-0-Q LAUNDRY | PORT SIDE, WEB FRAME (160) WHERE IT MEETS THE SHELL AND MARGIN PLATE, ENTIRE BILGE POCKET AREA | APPROX 1 SF OF WEB FRAME (164) IS HOLED. APPROX 80 SF OF BILGE AREA HAS RUST AND PAINT SEPARATION. |

WEB FRAME (160) WHERE IT MEETS SHELL AND MARGIN PLATE IS HOLED. WATER IS TRAPPED IN THE BILGE POCKET. WEB FRAME (160) SEPARATES THE LAUNDRY AND THE CHT ROOM.

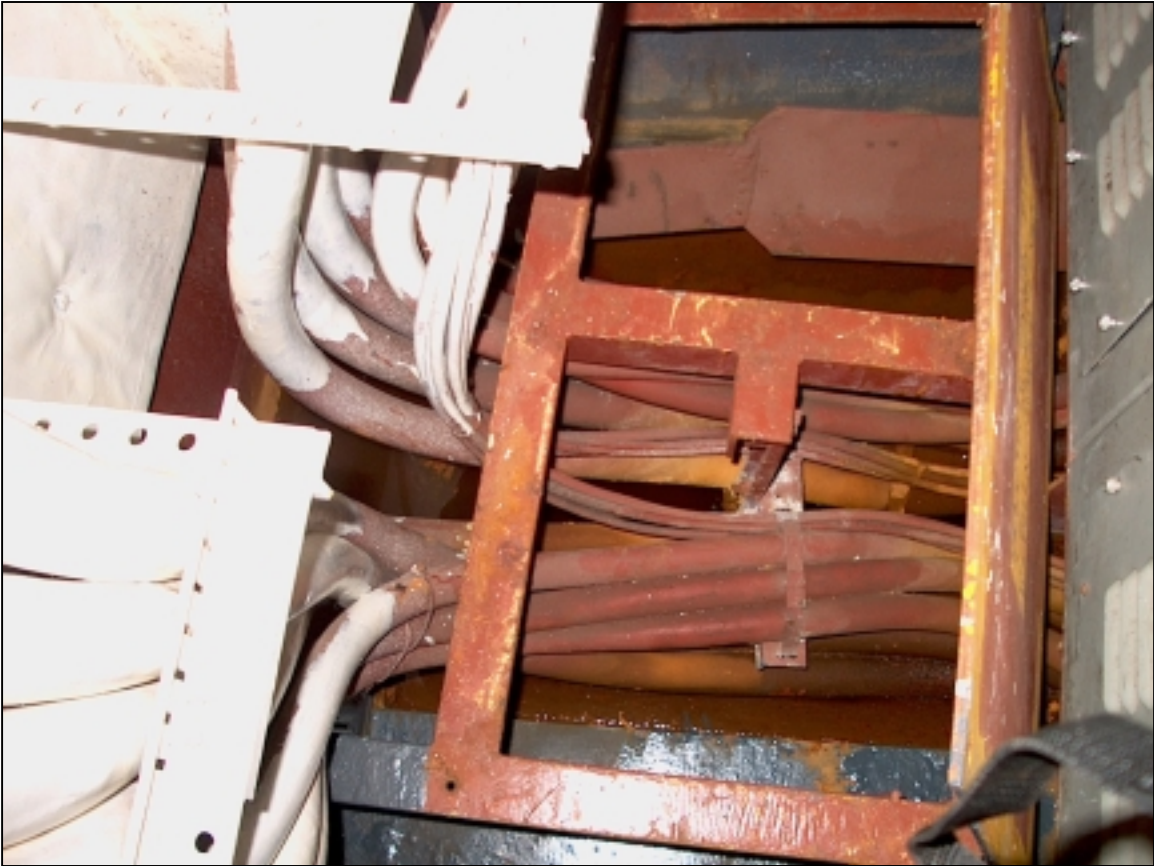
| LOCATION | AREA | RESULTS |
|---|--|---|
| 4-100-0-E APU MACHINERY ROOM | STBD SIDE BILGE POCKET | APPROX 20 SF OF BILGE POCKET FULL OF WATER, LIGHT CORROSION AND POWER CABLES ARE SUBMURGED. |

STARBOARD SIDE, BILGE POCKET BETWEEN APU POWER PANEL AND BHD (100)  
BILGE POCKET IS FULL OF WATER AND POWER CABLES ARE SUBMERGED.

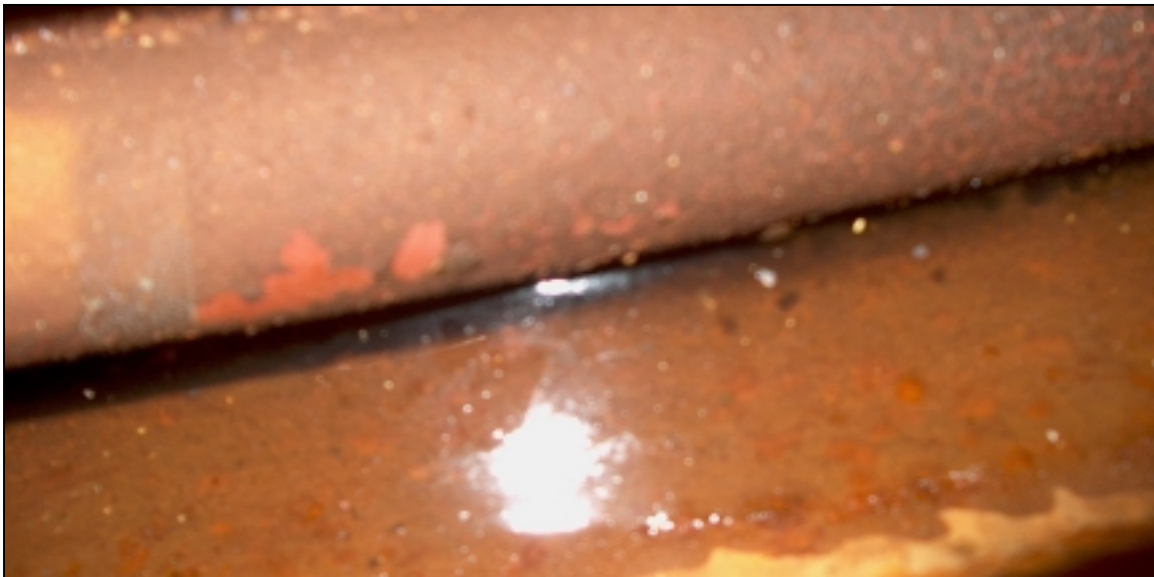
SUBMERGED POWER CABLES IN STARBOARD BILGE POCKET.

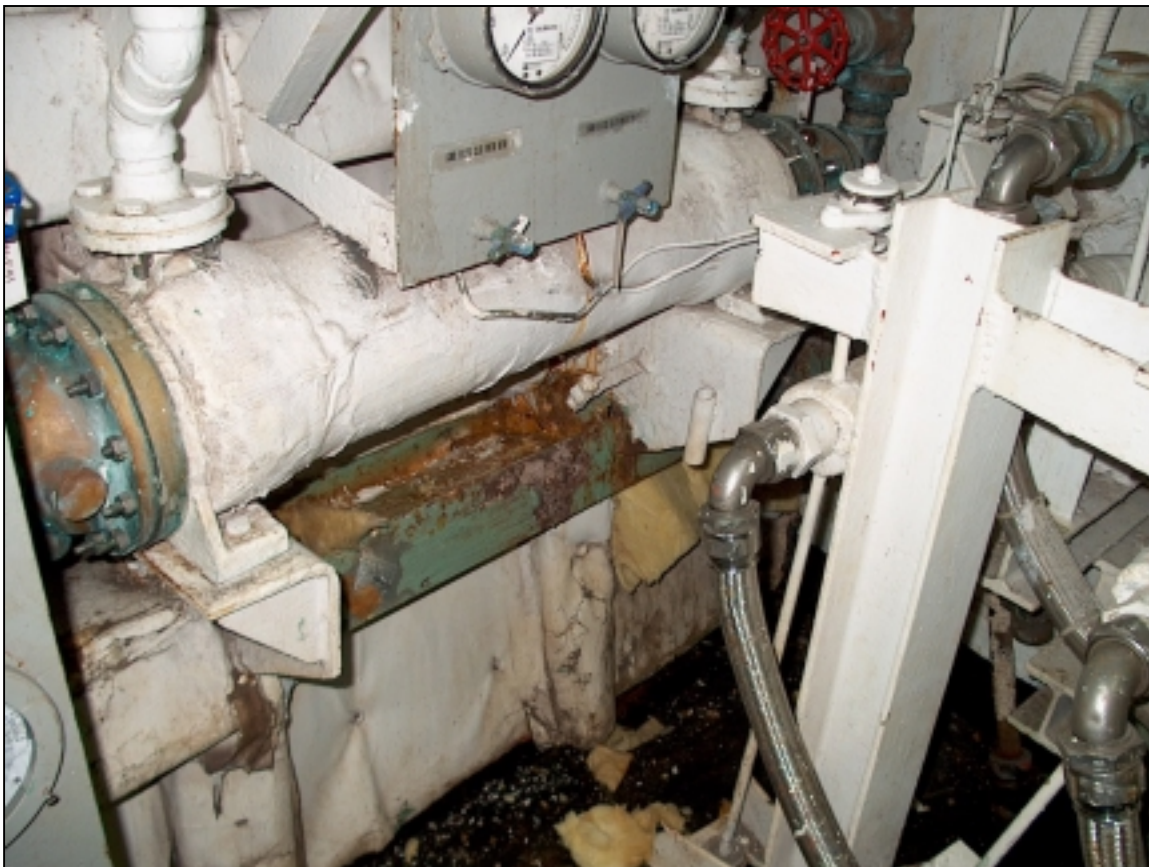
| LOCATION | AREA | RESULTS |
|---|--|---|
| 4-48-1-Q SONAR COOLING ROOM | STBD SIDE, FROM DECK TO 3 <sup>RD</sup> STRINGER AND BHD (56) | APPROX 48 SF OF SATURATED LAGGING. BHD 56 HAS LIGHT CORROSION. |

SATURATED LAGGING FROM DECK UP TO 3<sup>RD</sup> STRINGER. REMOVAL OF LAGGING FROM DECK TO 3<sup>RD</sup> STRIINGER, CLEANING TO BARE METAL, PRIMING AND PAINTING WITH ANTI-SWEAT PAINT IS HIGHLY RECOMMENDED. THIS IS A TYPICAL HIGH CORROSION AREA FOR (FFG-7) CLASS SHIPS. OTHER SHIPS IN THIS CLASS HAVE REMOVED LAGGING AND REDUCED CORROSION GREATLY.

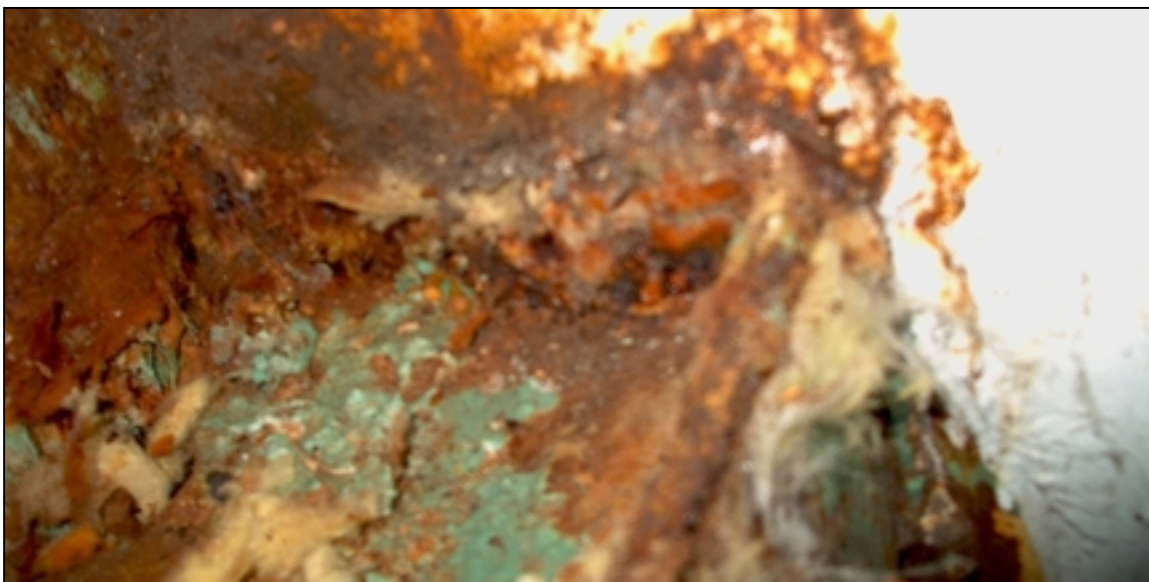
FIRST STRINGER FROM DECK AT BHD (56)

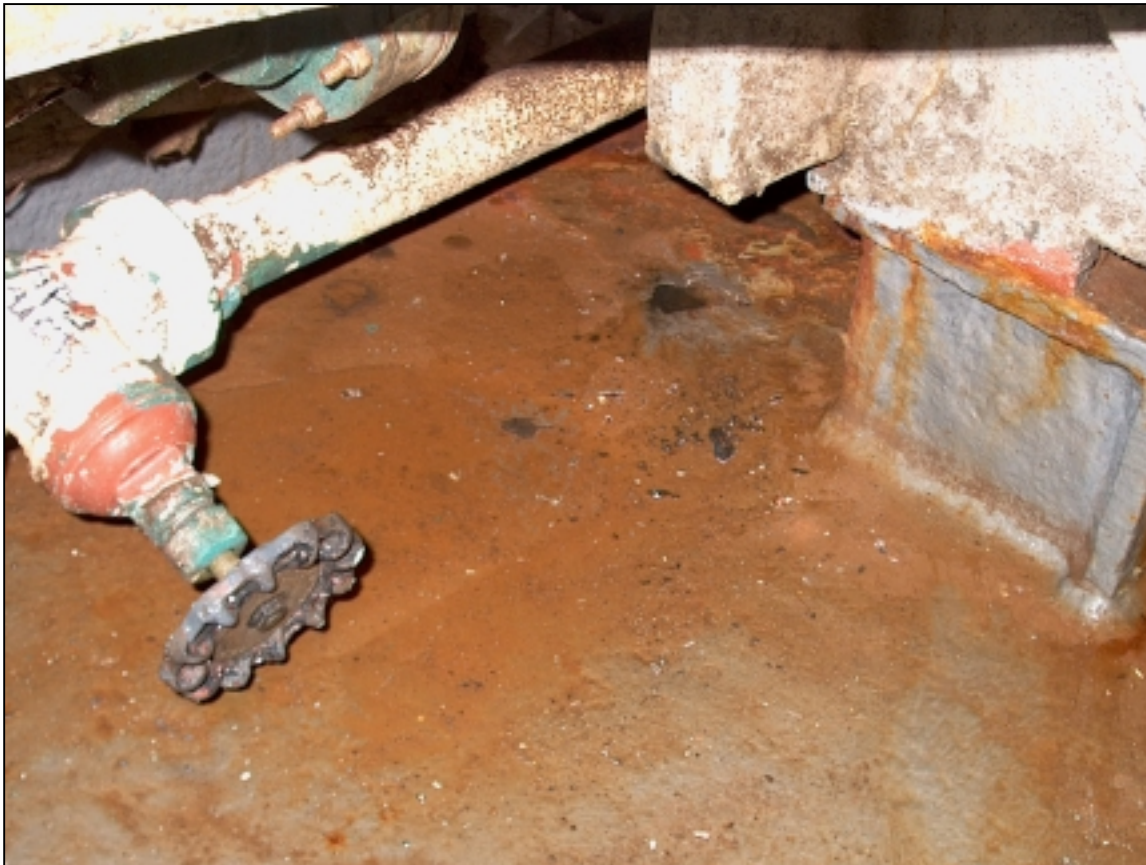
| LOCATION | AREA | RESULTS |
|---|--|---|
| 3-84-0-E A/C MACHINERY ROOM | PORT SIDE, TANK TOP / DECK | APPROX 40 SF OF CORROSION AND LIGHT THINNING. |

TANK TOP / DECK INBOARD OF A/C PLANT. MINOR THINNING WAS NOTED.  
THIS IS A COMMON AREA FOR CORROSION ON (FFG-7) CLASS SHIPS.

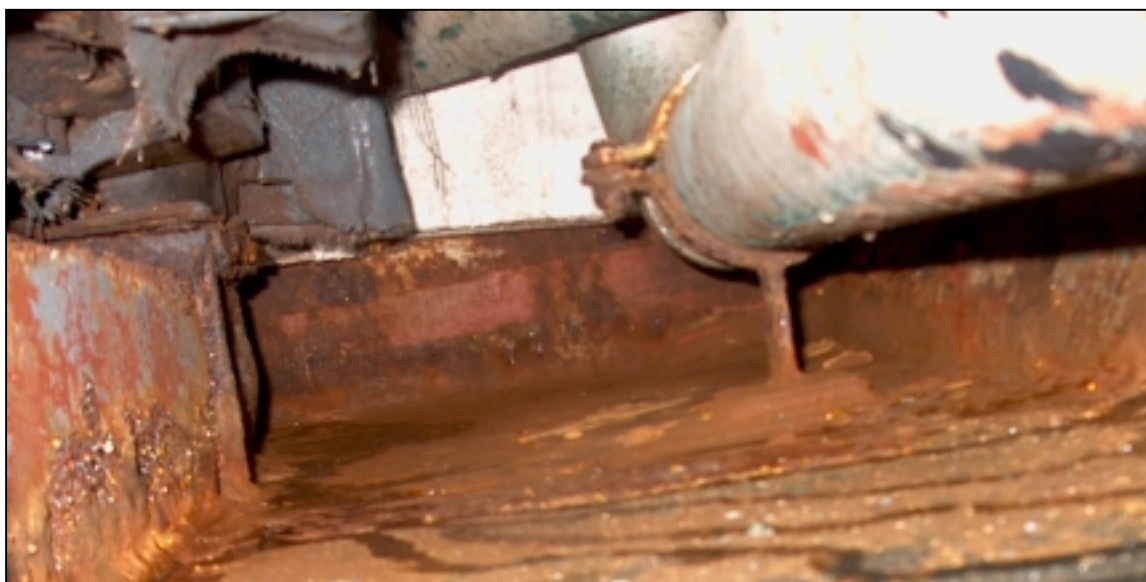
TANK TOP / DECK AND BHD (100) BETWEEN A/C PLANT AND PORT SHELL. BECAUSE  
THE A/C PLANT IS SO CLOSE TO BHD (100) AND THE PORT SIDE SHELL PROPER  
MAINTENANCE IS IMPOSSIBLE.
